SERVICE BULLETIN

EM10-003

August 23, 2010

EXHAUST HEAT SHIELD NOISE

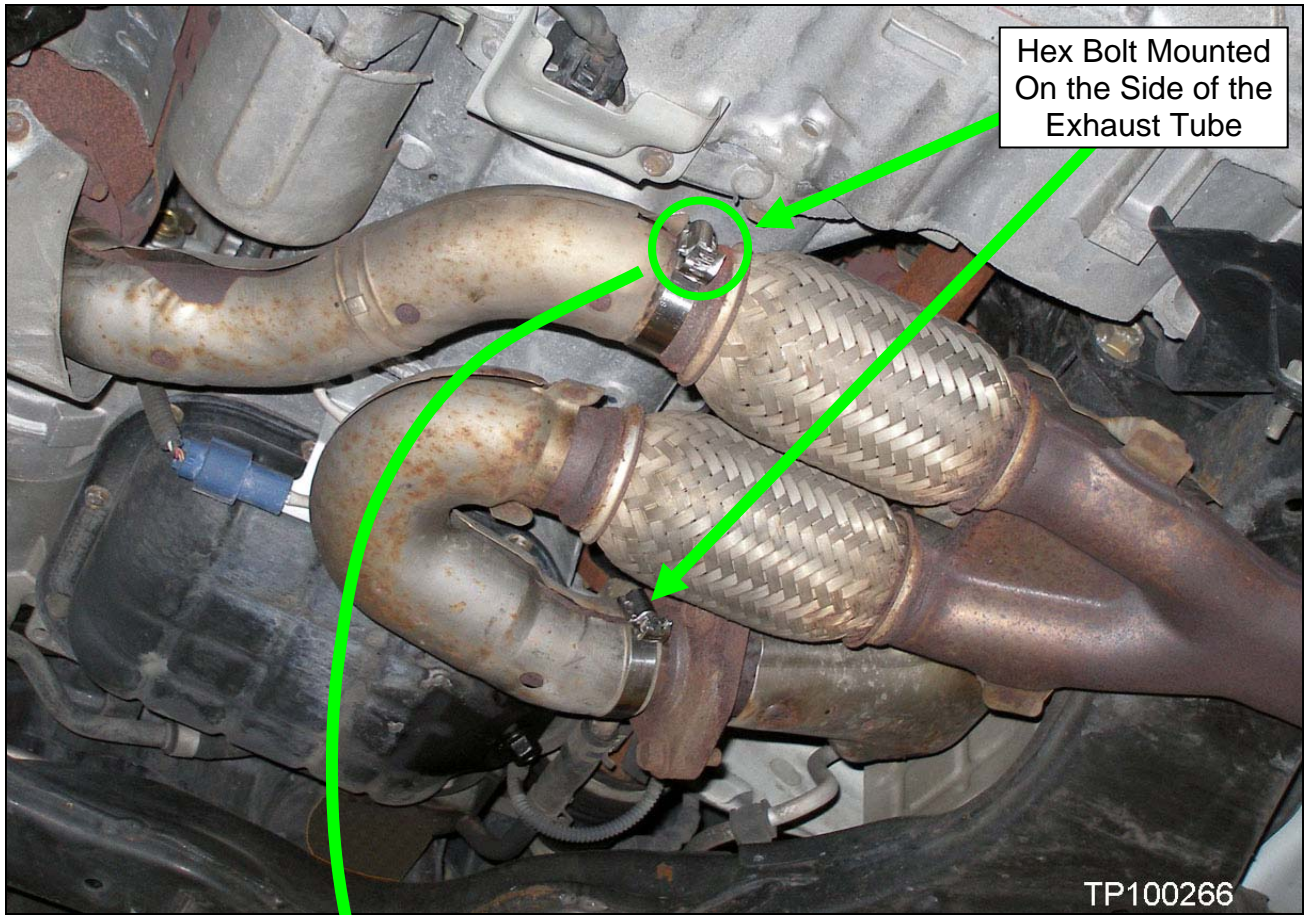
1. Raise the vehicle on a hoist.
2. Inspect the heat shields on the front exhaust tube for the following:
 - Heat shield contact with the exhaust tube.
 - Separated / missing band clamp(s).
 - Weld separation(s).
3. If a heat shield is found contacting the exhaust tube, pry it away to allow a minimum 1 mm (.040 inch) space.
 - Road test the vehicle to verify the repair.
4. If a weld or band clamp is separated, or the band clamp is missing, install new band clamps as needed.
 - For band clamp(s) location, refer to the pictures (starting on Page 5) that applies to your vehicle.
5. Secure the band clamp with the hex bolt located on the side (or on top, if needed). See Page 4, Figure 1 for example.

WARNING: Do NOT install the hex bolt on the bottom of the exhaust tube.
